REPORT NO. 00-05

ORDNANCE DEFORMER ENGINEERING TESTS

### CP Manufacturing, Inc. Bouldin & Lawson Ordnance Deformer Engineering Tests

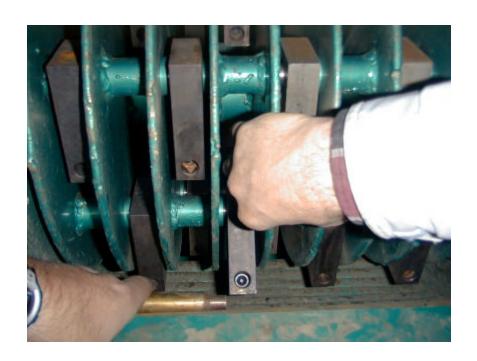
Photo 8. Bouldin & Lawson Rotary Drum Ordnance Deformer Showing the Drum's Cutters/Hammers

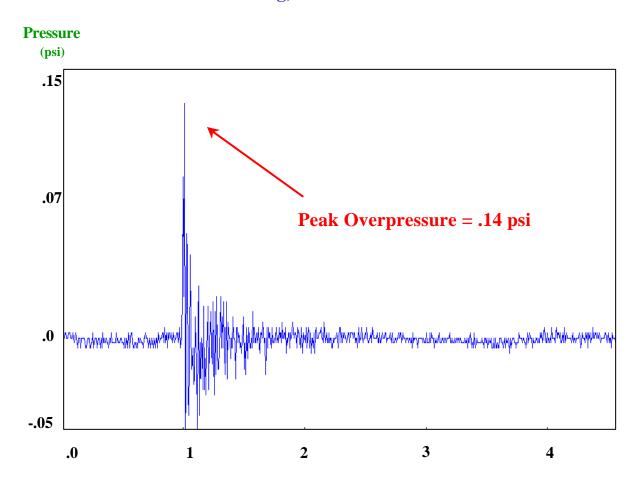
During the controlled blast, the maximum over pressure with the .50 caliber ammunition was .14 psi at the operator's position, with a maximum noise level of 142dbs. As was noted with the 5.56mm test, only the noise level is a safety hazard.

GRAPH 2
Results of Controlled .50 Caliber Blast on
CP Manufacturing, Inc. OD5000 Ordnance Deformer

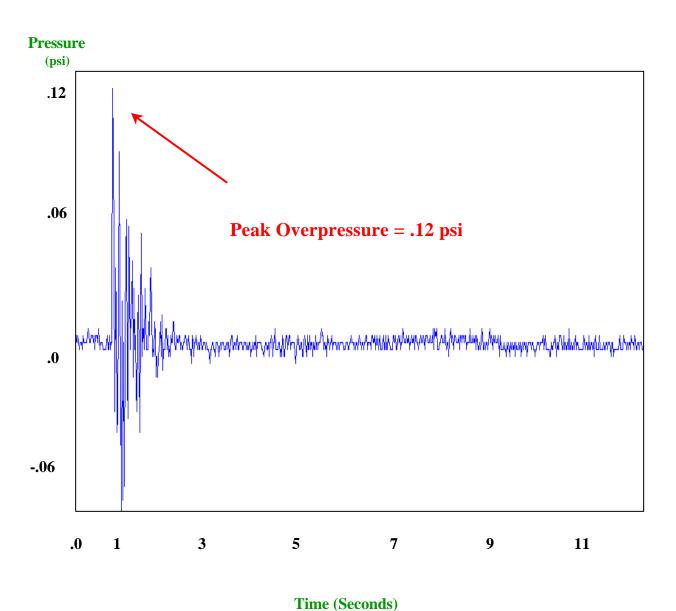
A.4. 20MM Ammunition. The 1% live ammunition was not processed through the CP Manufacturing, Inc., OD5000 Ordnance Deformer; however, a controlled live fire detonation was conducted. This test was to ascertain the maximum noise, overpressure conditions, and containment capability that exist during the detonation. To simulate a live round, an empty 20mm projectile was packed with C-4 and detonated using a blasting cap. During this simulation, the maximum noise level was 139 dbs with an overpressure at the operator position of .12 psi. Again, noise level is the safety hazard, not the overpressure. The

GRAPH 3
Results of Controlled 20mm Blast on
CP Manufacturing, Inc. OD5000 Ordnance Deformer

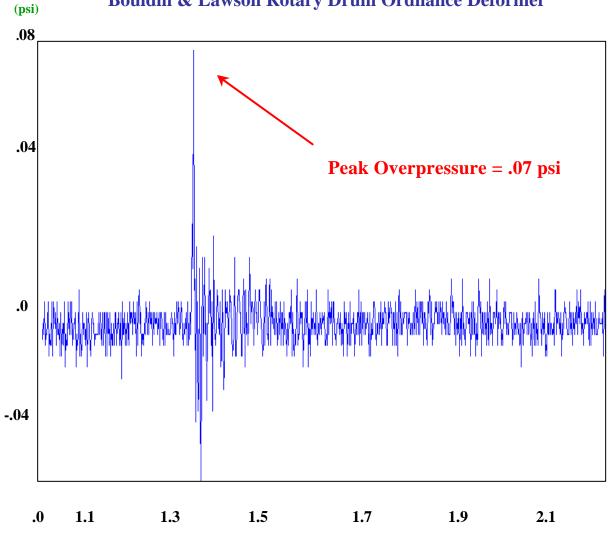
During the controlled detonation, the maximum overpressure with the 5.56mm under live fire conditions was .07 psi at the position of the operator. The maximum noise level during the live initiations was 131 dbs; again, well above the upper limits for hearing protection requirements.

GRAPH 4
Results of Controlled 5.56mm Blast on
Bouldin & Lawson Rotary Drum Ordnance Deformer

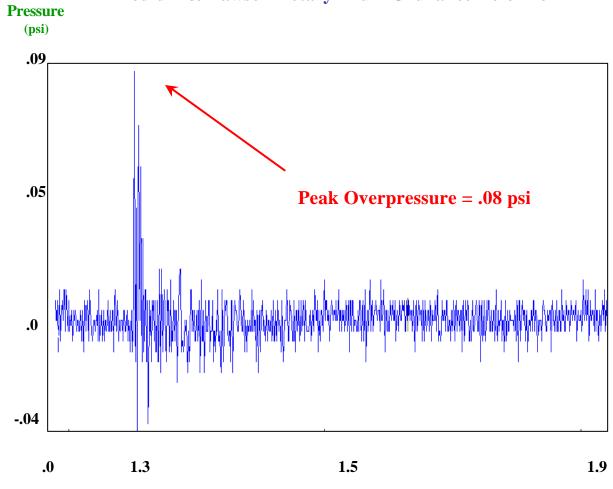
During the controlled detonations, the maximum overpressure during the .50 caliber test was .08 psi for the operator, at a maximum noise level of 130 dbs. As noted above, the noise level is the safety hazard while the overpressure does not pose a risk.

GRAPH 5
Results of Controlled .50 Caliber Blast on
Bouldin & Lawson Rotary Drum Ordnance Deformer
